## **Possible reasons why your ICD705 Aluminum Foil RF shielded SCIF room is not meeting the required shielding performance level**

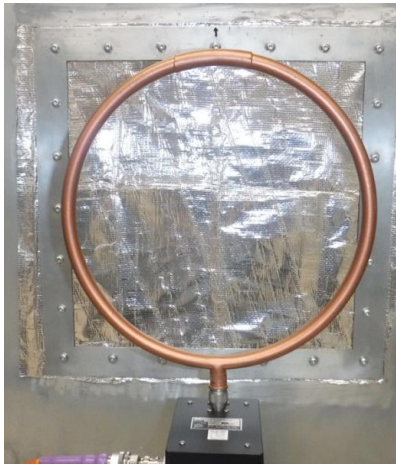
Example of how NOT to do the IEEE-299 test (no seams & no tape)

i) If the IEEE-299 test was done with only the foil covering the complete opening, the resulting performance is much better than it should be. How do you install 48" wide foil rolls on to the

SCIF wall without seams and tape? Even with Z-fold installation there are seams and you need to tape across it with electrically conductive PSA (Pressure Sensitive Adhesive) foil tape.

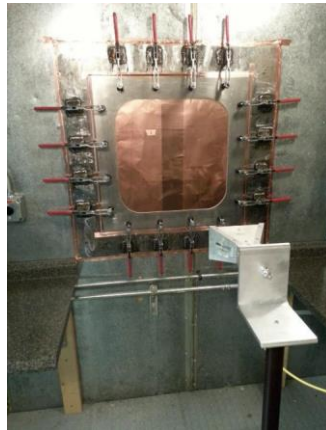
Example of how to do the IEEE-299 test correctly (with seams and tape)

ii) The correct way to perform the IEEE-299 testing is to have the seams and tape included in the test sample. This way you get an accurate result of the RF shielding effectiveness of the SCIF, if installed correctly.

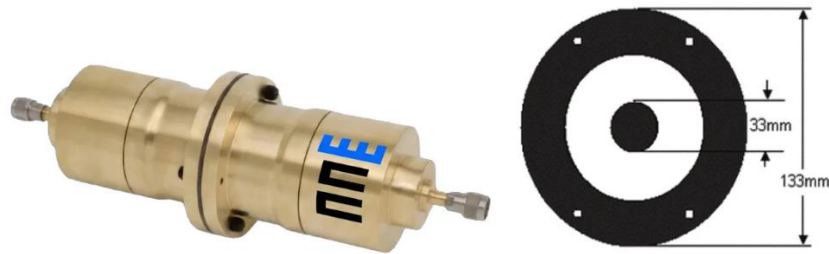
Example of an ASTM D4935 Test Setup

i) ASTM D4935 provides a procedure for measuring the electromagnetic shielding effectiveness of a planar material for a plane, far-field electromagnetic wave. From the measured data, near-field shielding effectiveness values may be calculated for magnetic sources for electrically thin specimens. Electric field shielding effectiveness values may also be calculated from this same far-field data. Small sample is tested using a coaxial transmission-line fixture.

ii) ASTM D4935 Specimen Size Limits: Outer Ring / Load Specimen: Outer diameter 133.1 mm (5.24 in), inner diameter 76.2 mm (3.00 in). Inner Disk (Reference part): Diameter 33 mm (1.30 in).

in). Material Thickness: Must be "electrically thin" relative to the wavelength and typically limited to a thickness that can be securely clamped in the coaxial fixture without distorting or damaging the material (generally under 1.5 mm to several millimeters depending on rigidity).
